Death in the line of duty...

A Summary of a NIOSH fire fighter fatality investigation

August 2, 2001

Residential House Fire Claims the Life of One Career Fire Fighter– Florida

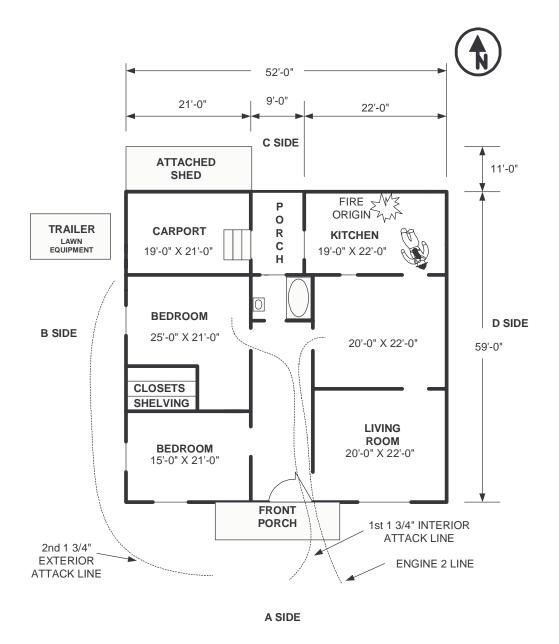
Diagram. Floor Plan

The structure involved in this incident was a single-story residential home (Photo 1). The structure measured approximately 52 feet by 59 feet. The structure had an attached roof on side C, measuring approximately 19 feet by 21 feet, which served as a carport. The fire's origin was determined to be in the kitchen (see Diagram). The fire was declared as accidental due to cooking.

that they encountered fire in a room near the kitchen (Diagram). They hit the fire three times with a fog stream and stated that the fire was quickly knocked down, but not completely extinguished. Given the information that the victim was in a room off to their left, they retreated and entered the doorway of the room on their left and recalled seeing a small fire. They opened their line on this fire and the Lieutenant's low-air alarm sounded. Noticing that all fire fighters on the scene were occupied, the IC radioed dispatch at 0150 hours requesting a second ambulance, Engine 6, and Rescue 36. Engine 3 arrived on the scene at 0152 hours and was ordered to pull a handline from their engine and protect the D exposure.

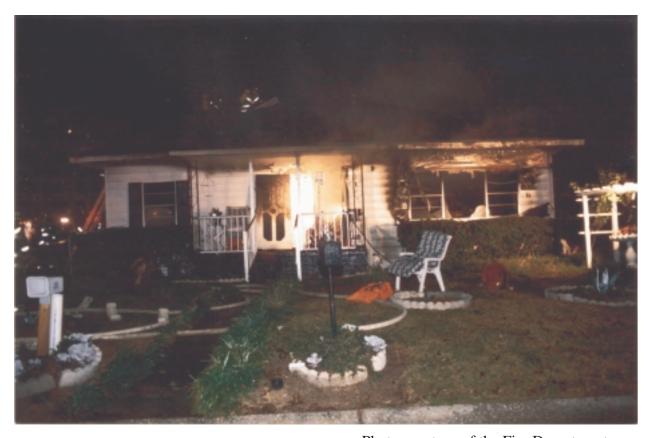
Photo 1. Single-Story Residential Home

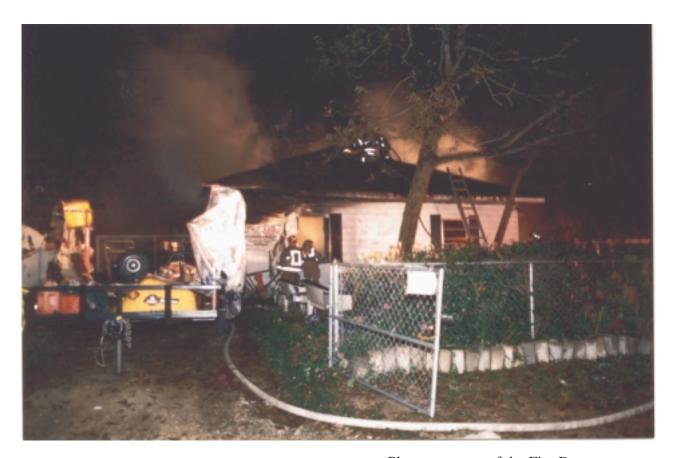
Photo 2. B/C Corner of Structure

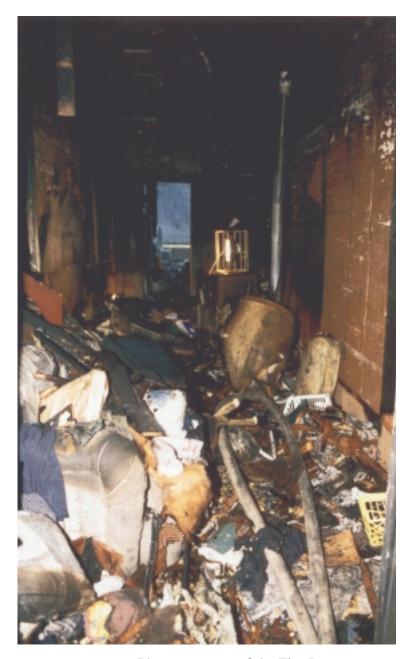
The search crew (the victim and the Captain and Lieutenant from Rescue 32) advanced their handline through the front door and down the cluttered hallway toward the rear of the structure (Photo 3 and Diagram). Note: Fire fighters stated that there was debris and furniture throughout the hallway. The Captain and Lieutenant from through the front door, and search for possible Ladder 11 positioned the PPV fan in front of the

Photo 3. Interior Hallway

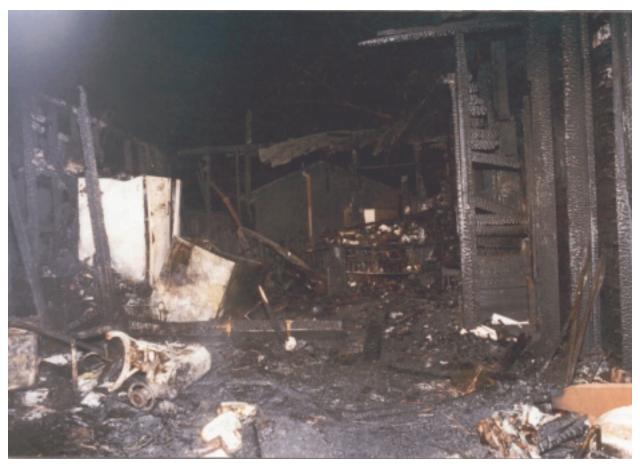
The Lieutenant and the fire fighter from Engine 1 opened their line up on a trailer with lawn equipment, which was burning in the rear. After knocking down most of the lawn equipment fire, they opened up a straight stream and applied it to the heavy fire emitting from the eaves of the partially collapsed carport (B/C corner) (Photo 4). Note: The Lieutenant stated that he never received a direct order of operation and was unaware that any fire fighters were inside the structure at this time. Shortly thereafter, the Lieutenant and the fire fighter from Engine 1 turned their hoseline to a small, burning shed, to the left of the covered carport. The Captain and Lieutenant from Rescue 32 stated that the victim, who was on the nozzle, entered a bedroom near the rear of the structure (Photo 5 and Diagram). The Lieutenant stood at the door of the room as the Captain remained in the hallway. The Captain and the Lieutenant stated that at this time the PPV fan was clearing up the heavy smoke conditions. The Captain from Rescue 32 stated that he looked into a room toward the D side of the structure (a room in front of the kitchen where the fire started) and saw a large amount of fire through the kitchen doorway. He yelled at the Lieutenant from Rescue 32, requesting the nozzle in fear that the room would flashover. The Lieutenant responded to the Captain's request stating that they could not locate the nozzle. With the heat intensifying, the Captain ordered the victim and Lieutenant to exit the structure immediately. At this point, the Lieutenant and fire fighter from Engine 1, who were on the B/C corner, recalled seeing the roof over the kitchen begin to collapse. The Captain from Rescue 32 stated that the Lieutenant turned and went in front of him toward the front door

Photo 4. Carport/Kitchen Area on B/C Corner

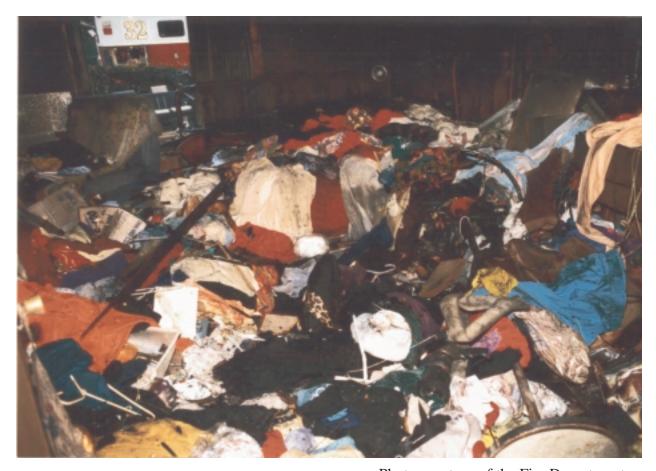
Photo 5. Bedroom

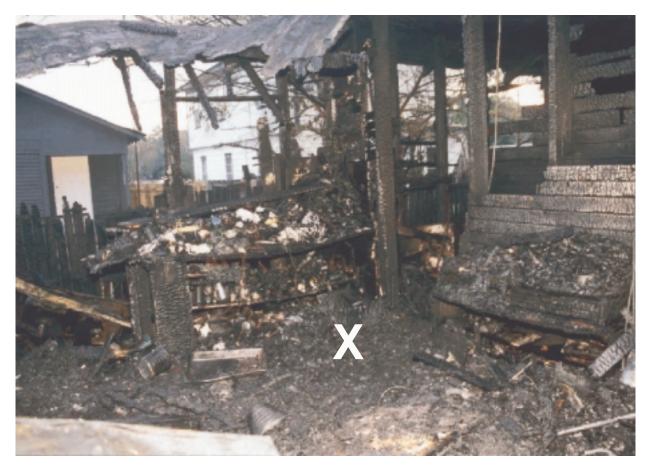
Over the next 40 minutes, several fire fighters took part in the search, which consisted of following the initial hoseline taken inside by the search crew. The fire fighters stated that they had reached the nozzle and the victim was not near it. The fire fighters stated that the search was hampered by a large amount of debris, clothing, and furniture, which was throughout the structure (Photo 5). The fire fighters continued the search for the victim, thinking that he could have been under some of the debris. At 0234 hours, the crew from Engine 1, along with a Captain reported to be in the rear (C side), stated that a section of the roof near the kitchen was down, and they were attempting to knock down some hot spots and search that area. As the crew from Engine 1 hit the hot spots, the Captain searched through the burned-out debris in the rear, C side. At 0245 hours, the Captain was searching in the kitchen, near the doorway which led into the room off of the kitchen, and located the victim (Photo 6 and Diagram). The victim was found in his full array of personal protective • equipment, lying on his left side with his head

Photo 6. Victim's Position
